CASE STUDY

Volumetric mixer case study

March 24, 2020

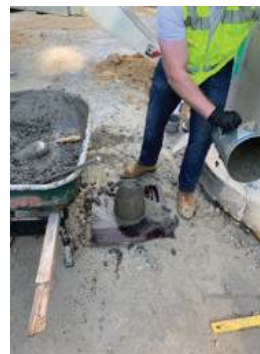
Slump Test

The material being produced was tested prior to the delivery being started, and several times during the placement. Each test met the parameters called for.

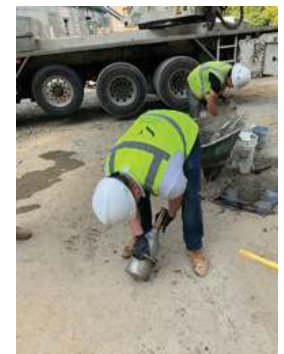
Roll-Meter Being Used for Air Test of Lightweight Concrete
